**Report to the Maryland Public Service Commission
on the Progress of the Maryland Electric Reliability Tree Trimming
Council (MERTT) in Addressing Commission Order # 79159
Regarding Recommendation for Specific Actions that Utilities Can
Take to Best Manage Privately Owned Trees Adjacent to and within
Utility Rights-of-Way.**

Niles L. Primrose
Power Plant Research Program
Maryland Department of Natural Resources
Tawes Bldg., B-3
Annapolis, MD 21401

August, 2010

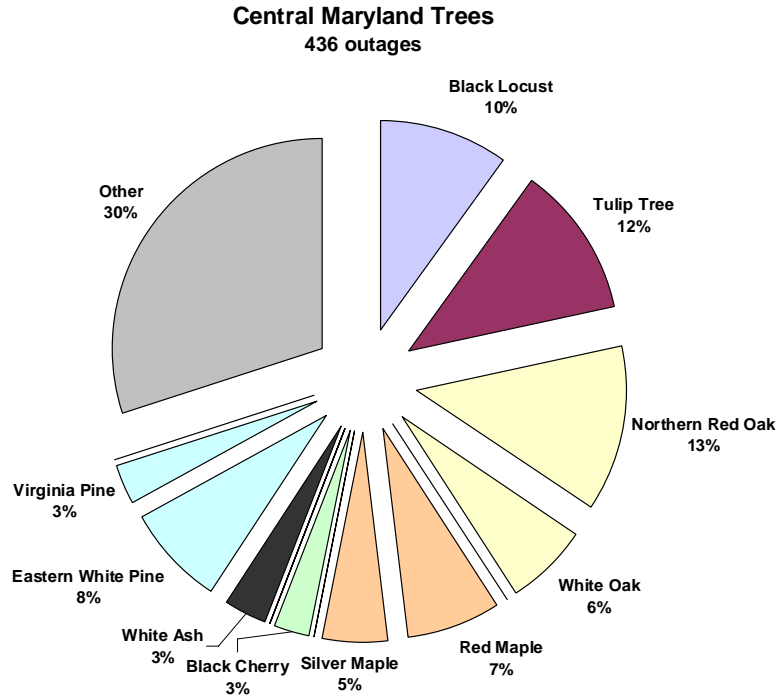
Figure 6. Percent of Qualifying Outages by Tree Species, DNR Central Region

(sugar, red and silver), oaks (red and white), tulip poplar, and black locust (Figure 4). Figures 5 through 8 illustrate how the predominant problem group/species changes by region, with a predominance of black locust and maple species out west, oak species and poplar in the Central region, a predominance of maple and oak species in the east, and pine, maple and oak species predominating in the south. While maple species were not the most problematic species overall, they were more likely to be within the right of way across all regions. Oak species also had relatively high incidents of being within the rights of way in the Southern region, as did tulip poplar within the Central region. Consistent with the testimony from Case #8977, the outage investigations are showing that a large majority of the outage causing trees originate from outside of the utility rights-of-way (Figure 9). Figures 10 through 13 break out the most numerous outage causing trees by origin within each region. The legend for figures 10 through 13 answers the question – Did the tree originate from off of the right of way? While a majority of the trees involved in outages were volunteers (i.e. seeded naturally, not planted by people), there were a limited number of species common to all regions that comprised the majority of the planted trees causing problems (Figures 14 through 17). Red and silver maples and white pines dominate this category. These species also dominated the outage causing species found within the rights of way. Regardless of species involved, limb failure and whole tree failure were the major causes of reported outages (Figures 18 through 21). Within the limb failure category, maples are the dominant outage causing species. Eighty-four percent of the trees investigated for this study had no external indicator of failure, thus would not have triggered utility maintenance action (Figure 22). Of those trees investigated that showed no external indicators of failure, approximately 45% had hidden defects that were only able to be noted after failure (Figure 23).

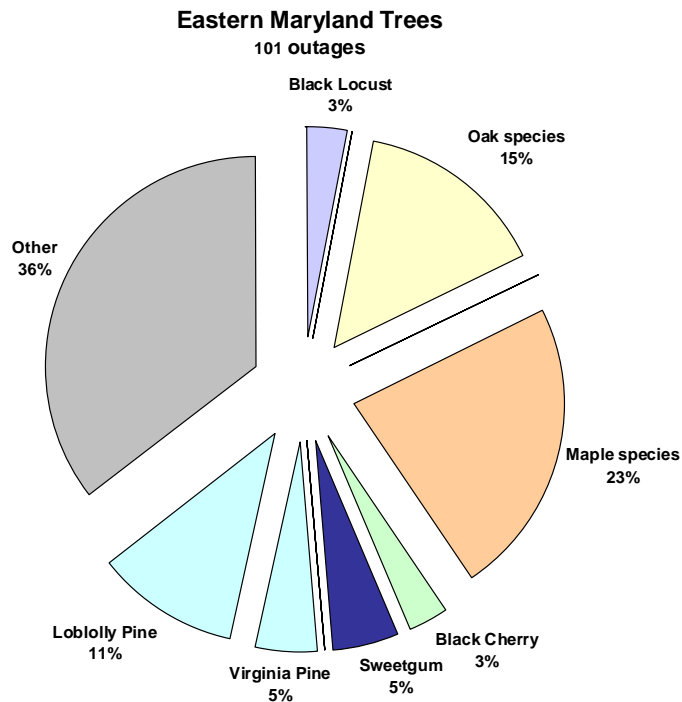
Figure 7. Percent of Qualifying Outages by Tree Species, DNR Eastern Region

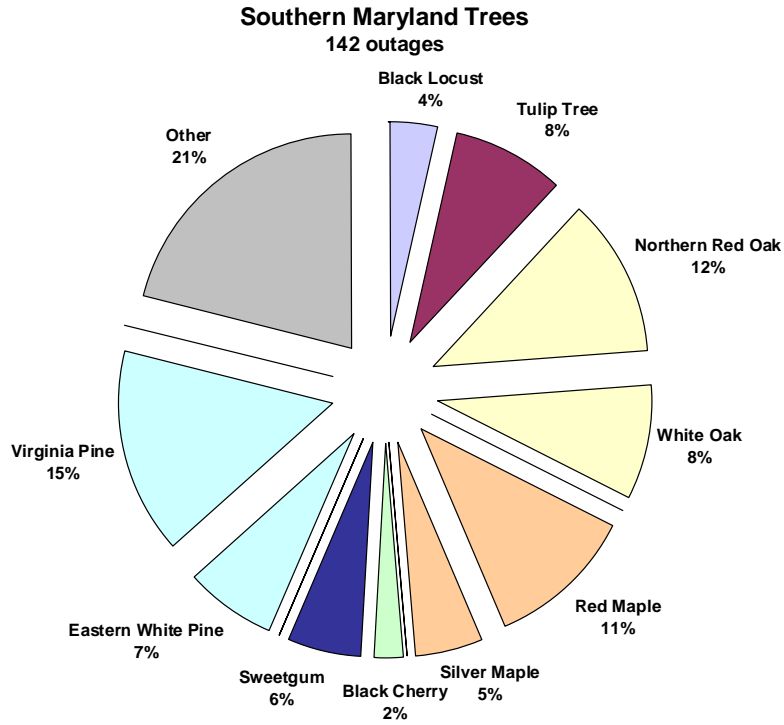
Figure 8. Percent of Qualifying Outages by Tree Species, DNR Southern Region

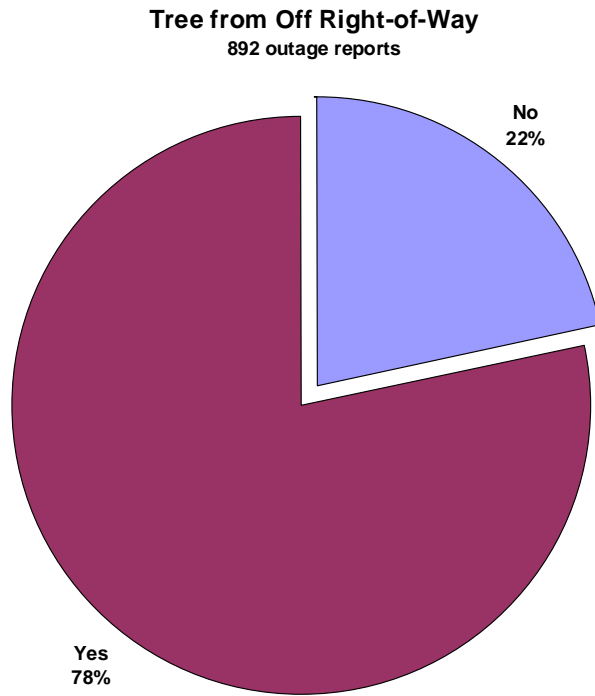
Figure 9. Percentage of trees on and off right of way causing outages, all regions combined.

As noted, the majority of the trees investigated as being the cause of an outage originate off of the utility rights-of-way and these trees have generally shown no indications of problems that would trigger current utility vegetation management actions. The utilities typically use external

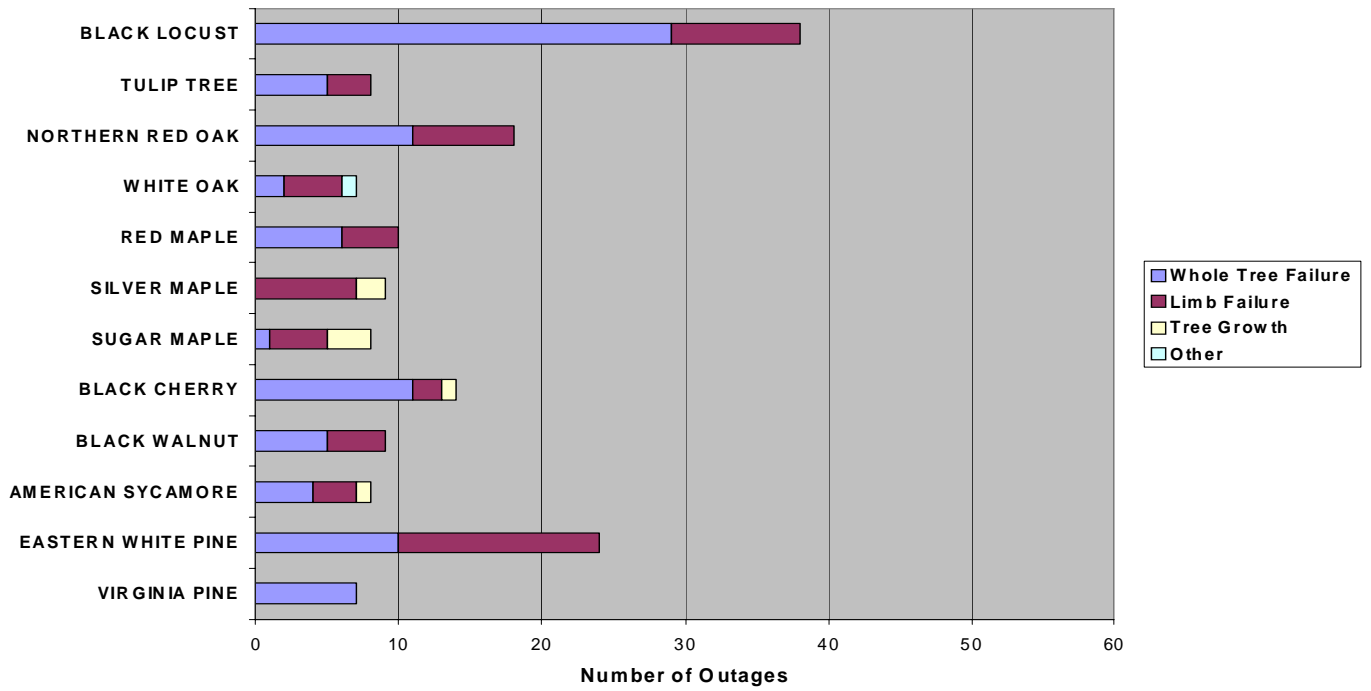
Western Region - Species Field Cause

Figure 18. Type of tree failure by species, Western DNR Region

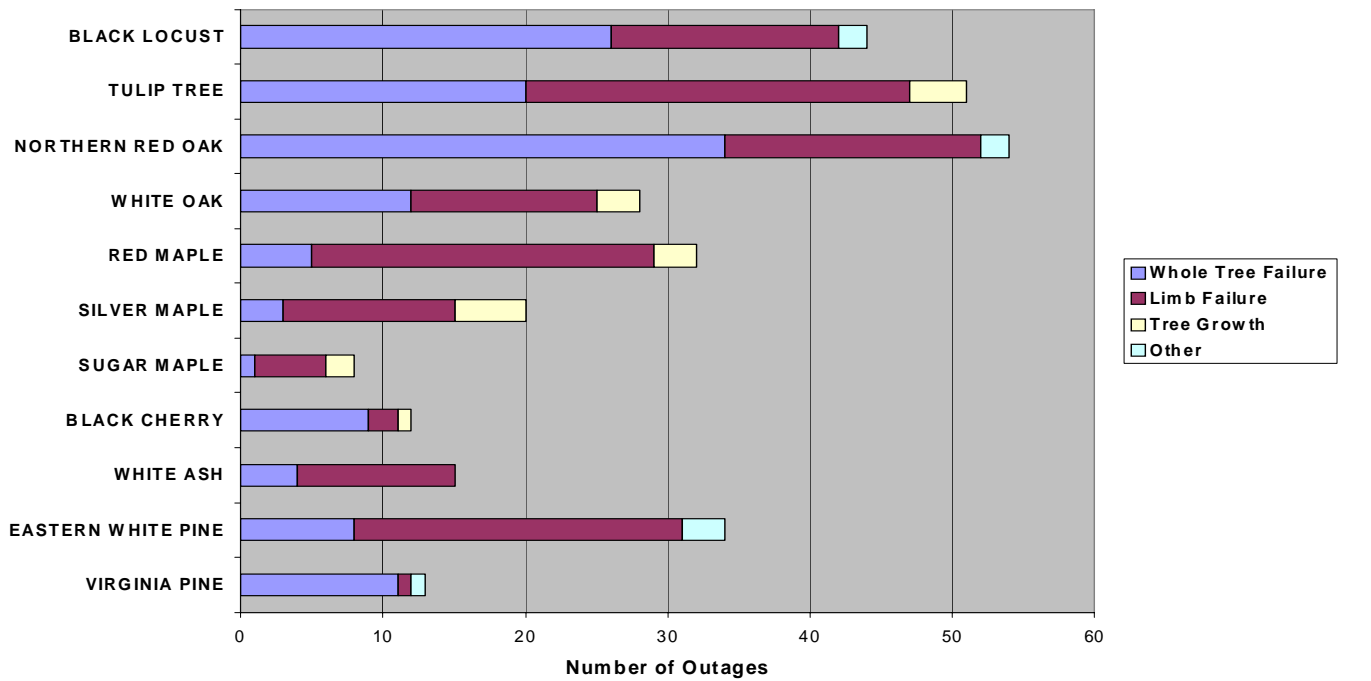
Central Region - Species Field Cause

Figure 19. Type of tree failure by species, Central DNR Region

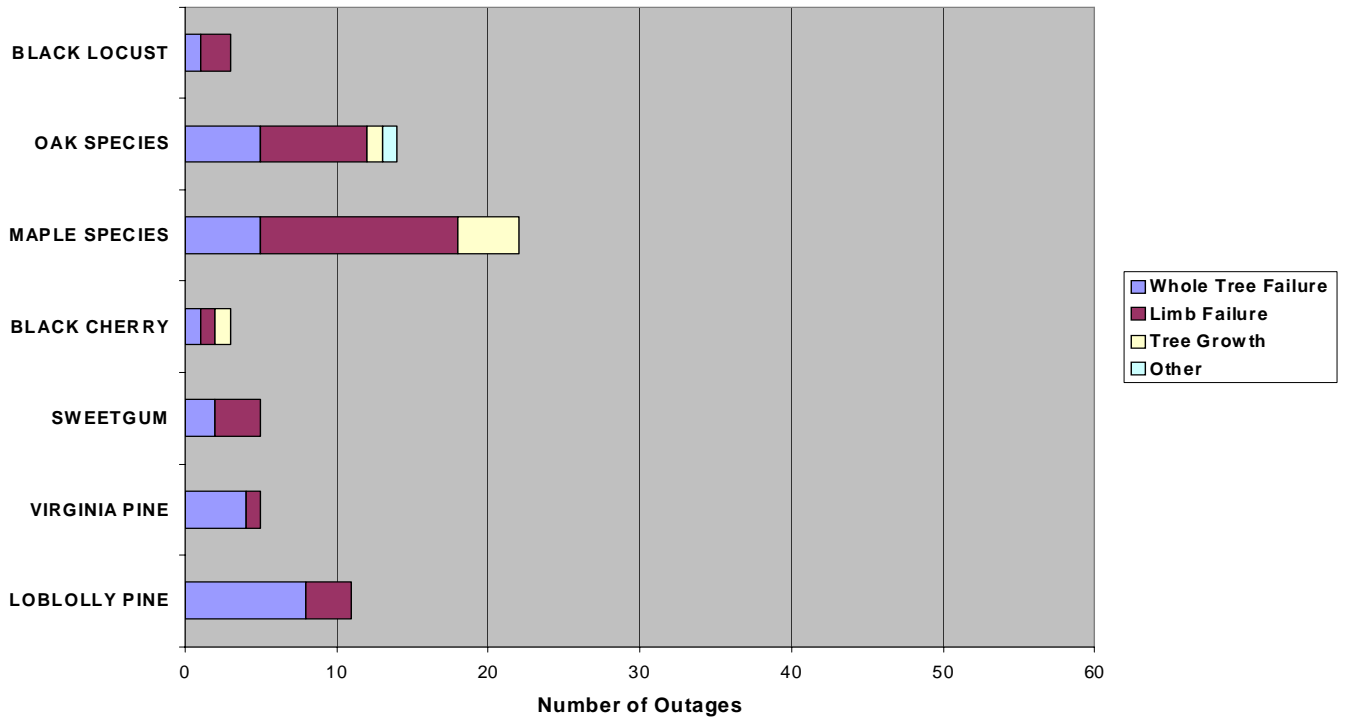
Eastern Region - Species Field Cause

Figure 20. Type of tree failure by species, Eastern DNR Region

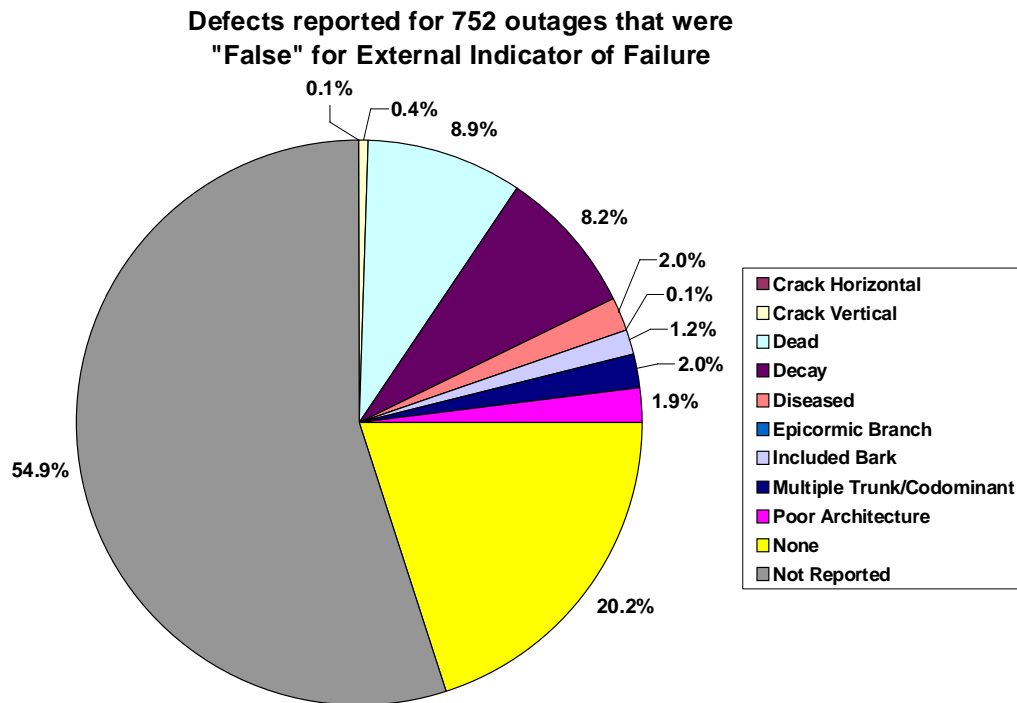
Figure 23. Percentage of hidden defects for trees with no external indicators of failure, all regions.

indicators to predict an increased risk of causing a power outage when identifying tree trimming or removal candidates. The presence of hidden defects only becomes apparent after tree failure. While this will be an ongoing problem, the MERTT program's ability to assist in identifying species prone to hidden defects and species that are prone to failure in general, such as black locust out west and maples and tulip poplar elsewhere, provides a well founded basis for targeting specific species for management activities that would otherwise be overlooked with current vegetative management programs. The information about limb or whole tree failure by species and tree age (size) also provides a solid basis for establishing species and age specific best management practices (BMPs), such as trimming red maple and removing black locust even when there are no external indicators of potential failure. The MERTT Program data will inform a utility forester's best professional judgment when specifying vegetative management actions.
